City of Encinitas

Level 3 Assessment of Blue Gum Tree

Near 1717 N Vulcan Ave

Asset I.D. # 8281ETREE

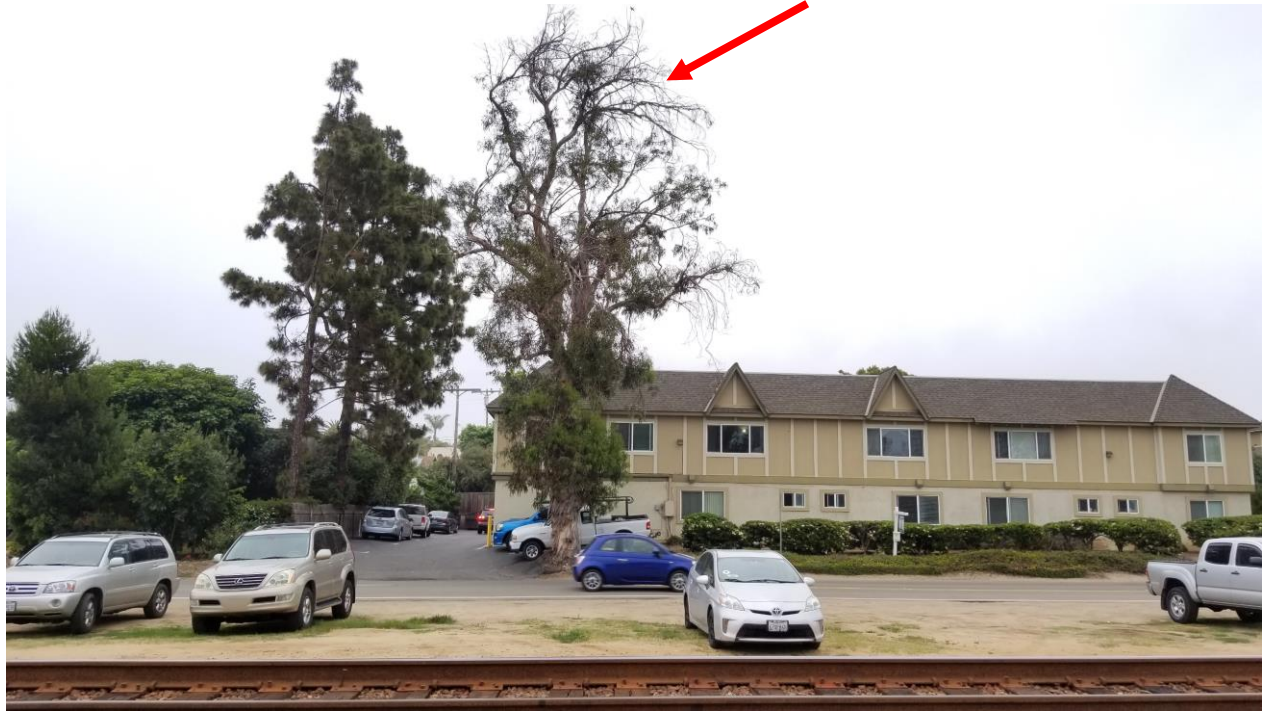
Photo #1

- The tree (red arrow) was located on the east side of N Vulcan Avenue in front of the 1717 building. There were branches growing above the road as well as over several parking spots and the 1717 building.
- The tree had a DSH¹ measurement of 36 inches and a height of about 85 feet.
- Judging by the color and density of the foliage, the tree was in poor health for the species and time of year. There was an abundance of branch dieback/ dead wood in the canopy.

WCA recommends removing the tree because of the moderate risk it is presenting, its declining health/ lack of vigor, and the signs of significant basal/ root decay associated with an incurable fungal pathogen. This decision would completely eliminate the associated risks and make space for a new tree(s) to help maintain a healthy and diverse urban forest.

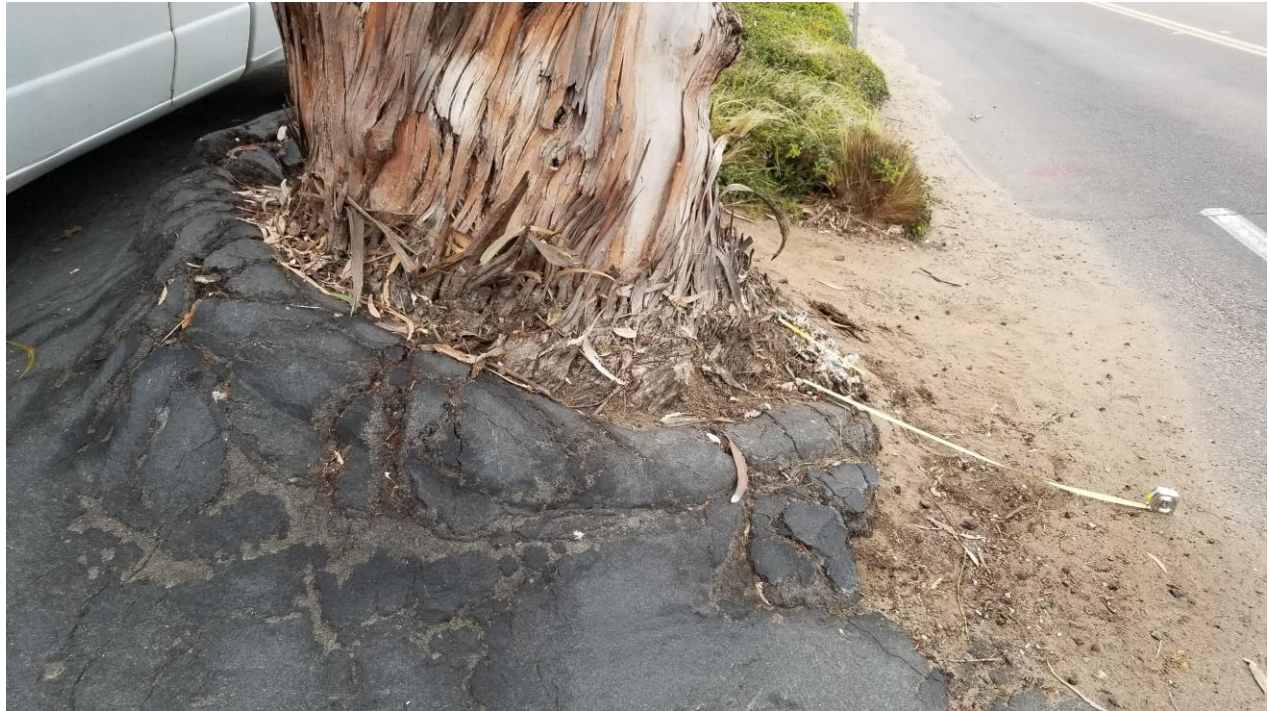
Photo #2

- The trunk of the tree was about 3 feet east of N Vulcan Avenue. There was pavement closely surrounding most of the tree's basal region.

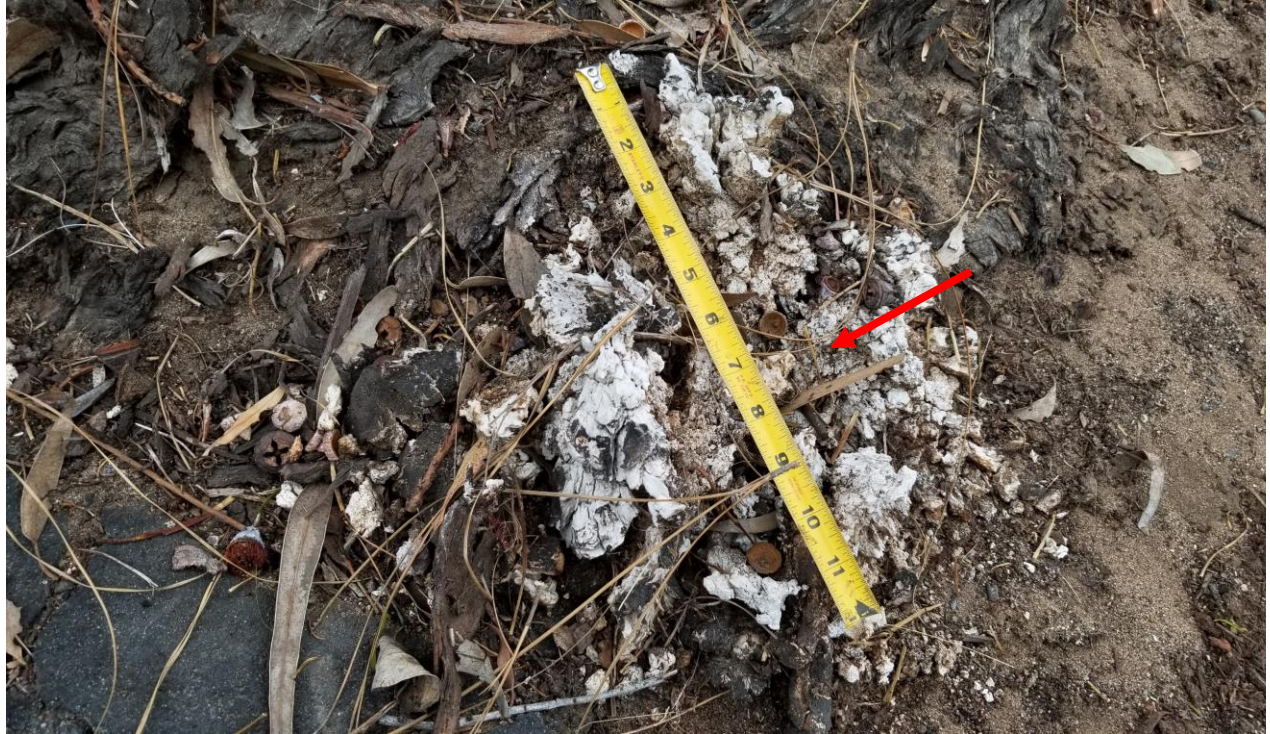
Photo #3

After completing the advanced trunk assessment, the defect of greatest concern was the indication of basal decay (see Appendix B) that likely extended further down into structurally important roots. This decay can significantly compromise the strength and elasticity of the wood which can lead to unpredictable failures. The *likelihood of failure* because of basal/ root decay was assessed as **probable** within the next 2 years if no mitigation is taken.

- The tree had remanence of what appeared to be sulfur conks (*Laetiporus spp.*) at the base of the tree's west side (red arrow).

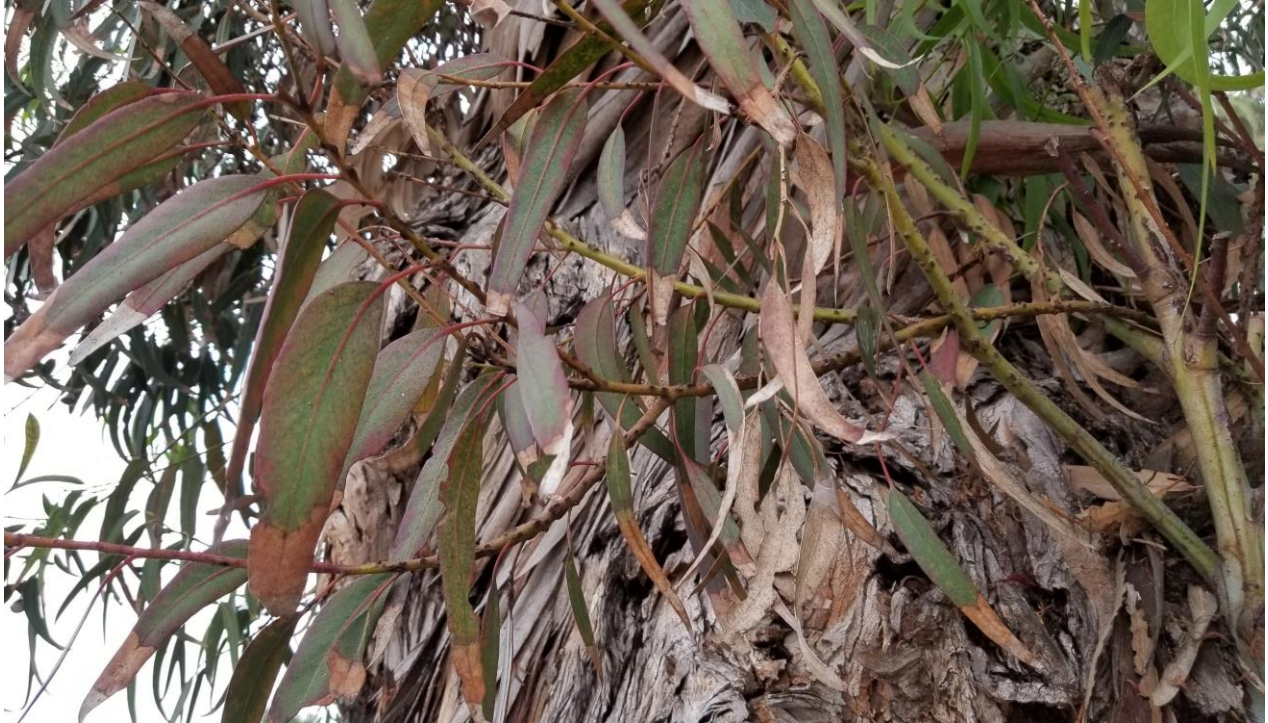
Photo #4

- There was an abundance of stressed epicormic growth on the tree's bottom half. Twigs had galls from wasps, and the leaves had marginal necrosis (tissue death) as well as tortoise beetle feeding damage.

Providing supplemental irrigation and treating for foliar pests may help reduce these stresses.

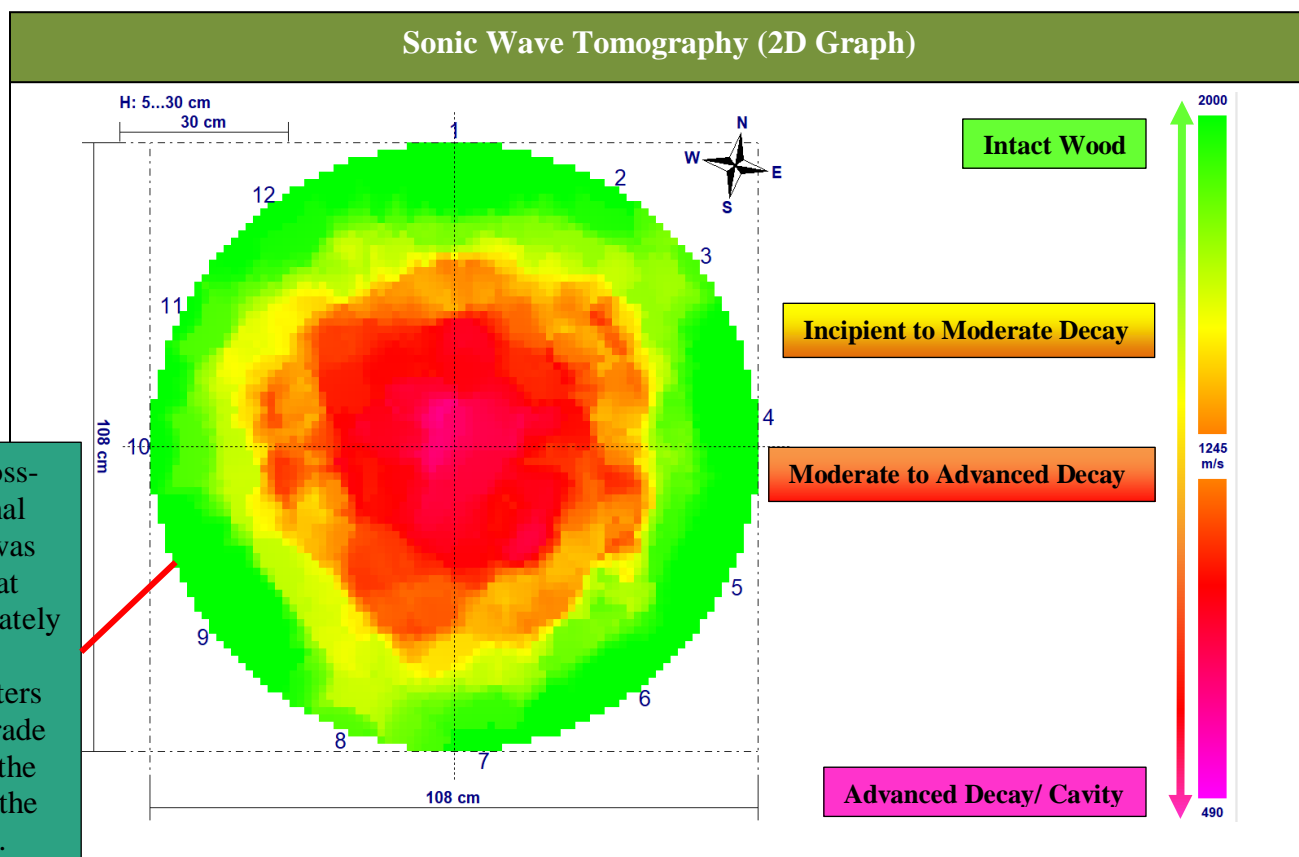
- Shown above is another 2D cross-sectional graph that was calculated from the line graph (by Arbotom software). This graph puts together a more visually relatable interpretation of what the density/ elasticity of wood inside of this cross-section looks like. As you can see, there appears to be significant amount decay (mostly moderate to advanced) that gets progressively worse towards the center of the trunk.
